FRACTOGRAPHIC ANALYSIS OF OPTICAL FIBERS

**J.J. Mecholsky, S.W. Freiman and S.M. Morey
Naval Research Laboratory
Washington, D.C. 20375**

November 1977

Interim Technical Report 1

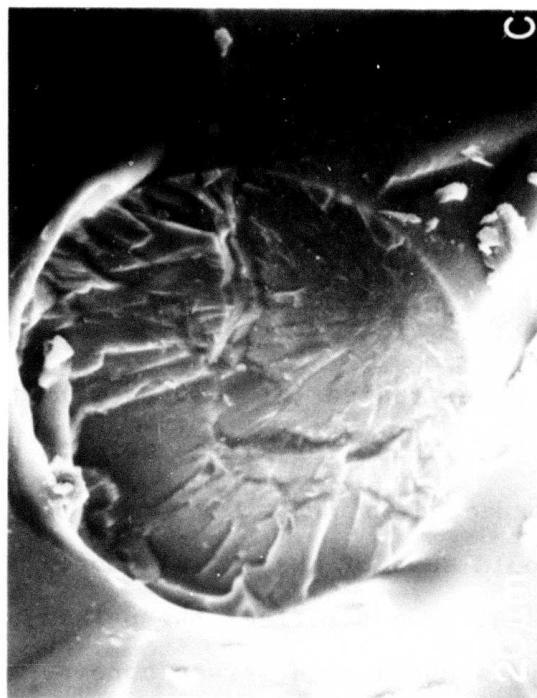
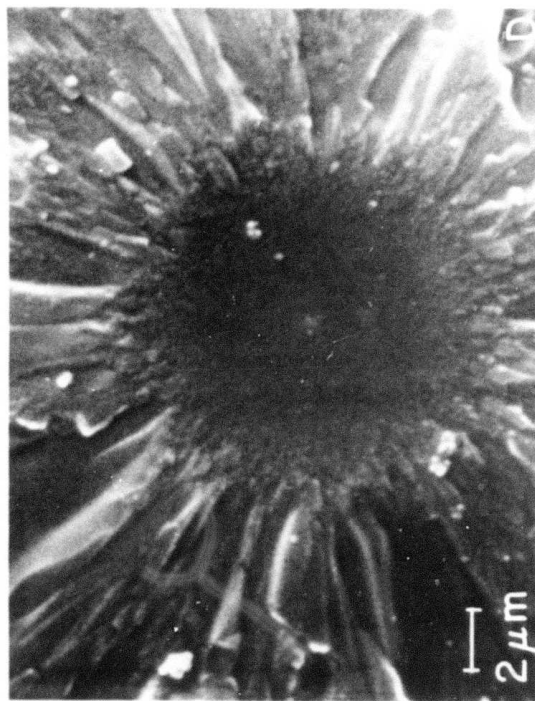
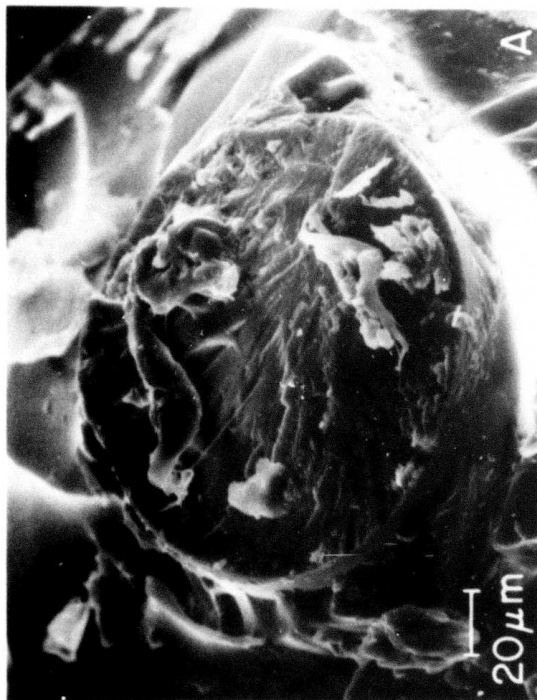
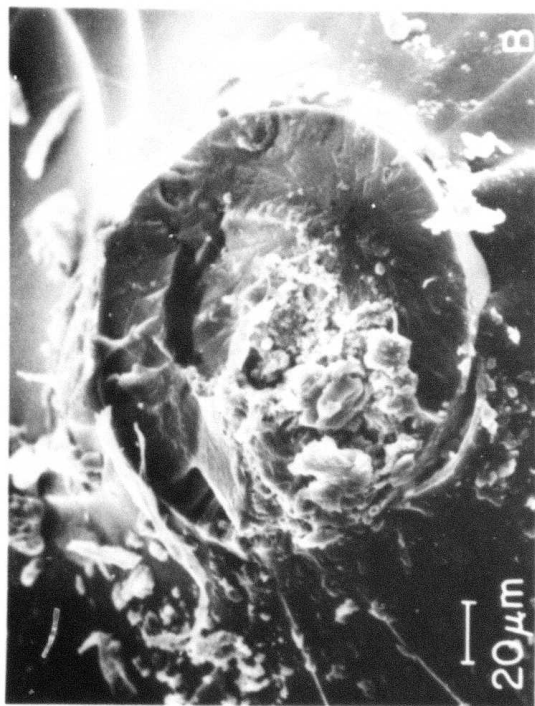
Several fibers were sent that were known to have low strength values. Fracture surface analysis determined that the low strength (approximately 200,000 psi) failures were probably occurring due to a defect that existed in the preform and was drawn out during the pulling of the fiber. This is concluded because there were several internal failures in the same general location in the plane of the fracture (cf Fig. 15a and b).

Fig. 15. SEM fractographs of three ITT fibers failing from internal sources. (A=770708-4; B=770708-3; C and D=770510-9.) The location of the origin in A & B and the other fibers of this set (Table II) indicate that the same type of source is probably causing failure. Although not certain, the white dot evident in D could be a small microcrystallite of silica.

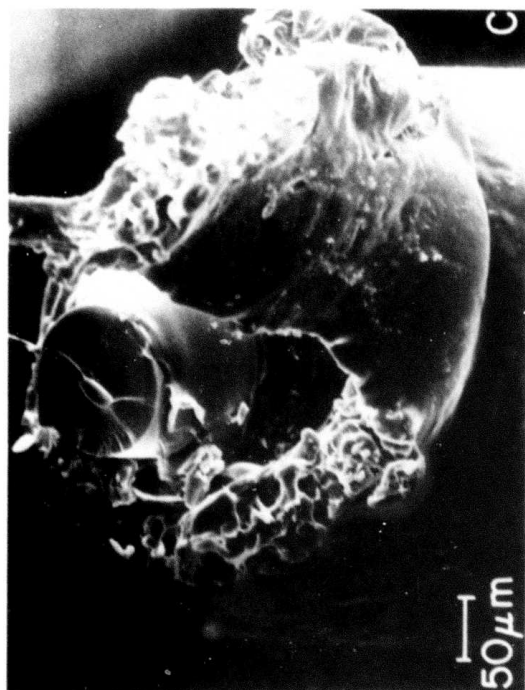
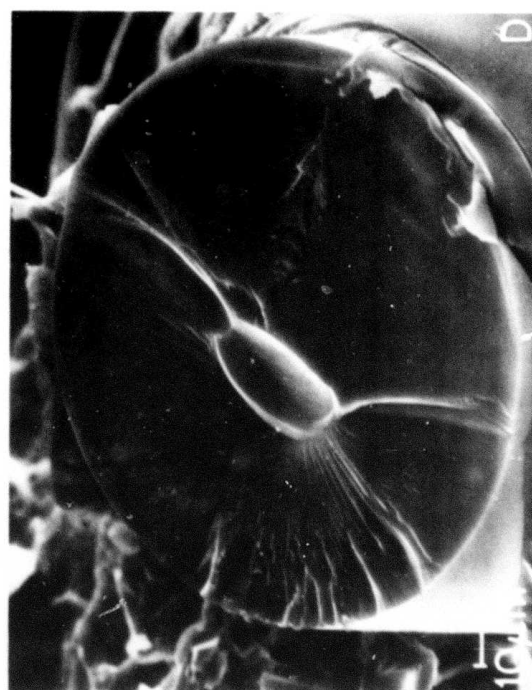
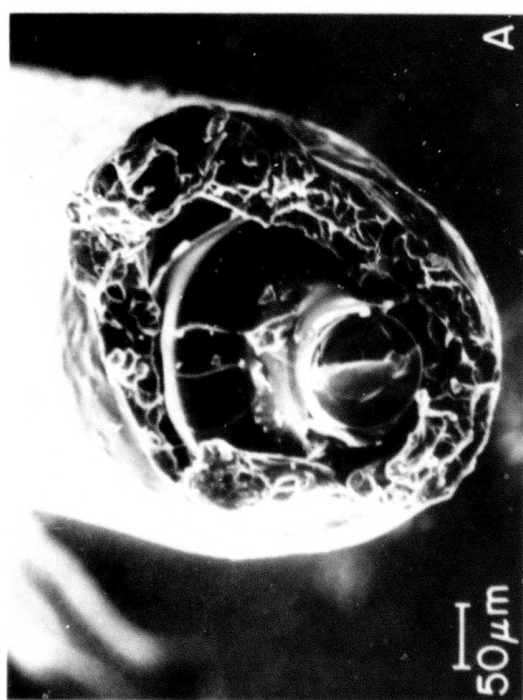
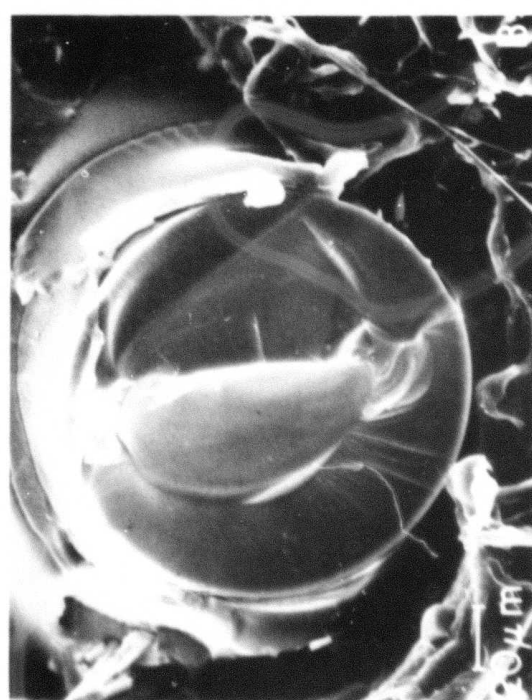
Of all the fibers observed (28 pairs) which were sent from NOSC, only two origins were found. The low yield is due to the fact that these fibers all had a relatively high strength since the pretest proofing at 300 ksi eliminated the weak fibers. These high strengths > 500 ksi mean that fracture origin determination is very difficult, if not impossible. However, two of the three fracture surfaces were similar in appearance (Fig. 15) to each other but not to any other fibers observed, either from ITT or Hughes. The large semi-elliptical sections in the interior of the fibers observed in Fig. 16 should have caused low strength breaks. The reported strength is $\sim 3500 \text{ MN/m}^{3/2}$ ($\sim 500 \text{ ksi}$), indicating that these fractures are probably secondary, rather than primary breaks. However, the question arises of why these large inhomogeneities did not cause failure at lower stresses as the primary break. Perhaps, because these inhomogeneities are SiO_x of a slightly different composition than SiO_2 , they were not high stress concentrators leading to low strength failure. The composition and identity of these anomalies is unknown but further research is being performed.

Fig. 16. SEM fractograph of an ITT fiber tested (at 3500 MN/m^2) at NOSC. A and B - 4-8; C and D- 2-6. These very large defects are unidentified, but would be expected to cause low strength ($< 700 \text{ MN/m}^2$) fractures. One would suspect, then, that these are probably secondary failures and do not reflect the primary break, or that the inhomogeneity is not a high stress concentration.
